SOLID POLYMER MEMBRANE PROGRAM

Final Report

Contract NAS 9-11876

GENERAL ELECTRIC

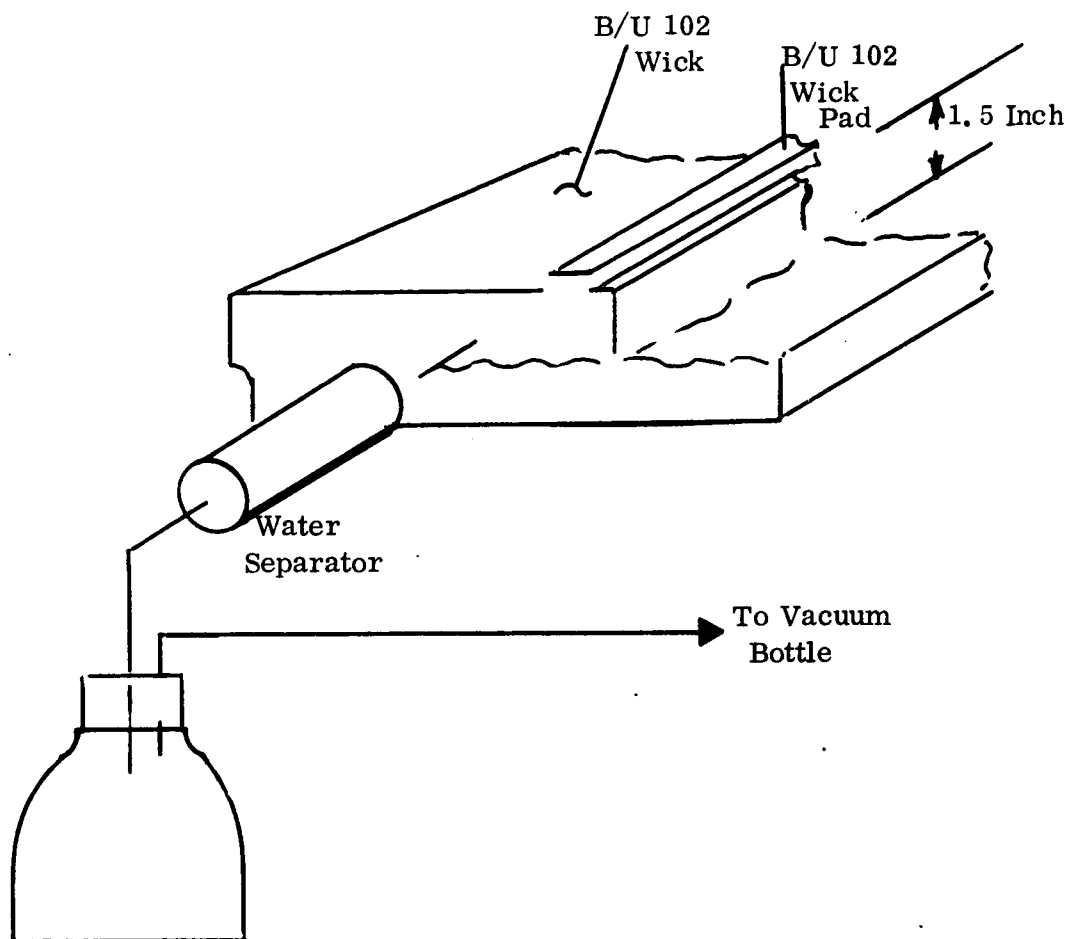
Figure 11. Simulated Water System Test Setup

The product water wicking and H₂ humidification pads were tested for wettability by applying droplets of water to their surfaces. Neither would readily absorb water. However, they would become wet if the water were rubbed into their surfaces. Suspecting that the wicking had become dry during the unscheduled shutdown, a simulated water removal system was set up and tested using a cell wick pad and water separator from B/U 102. The set up is shown in Figure 11. The entire system was enclosed to prevent evaporation from the wick surfaces.

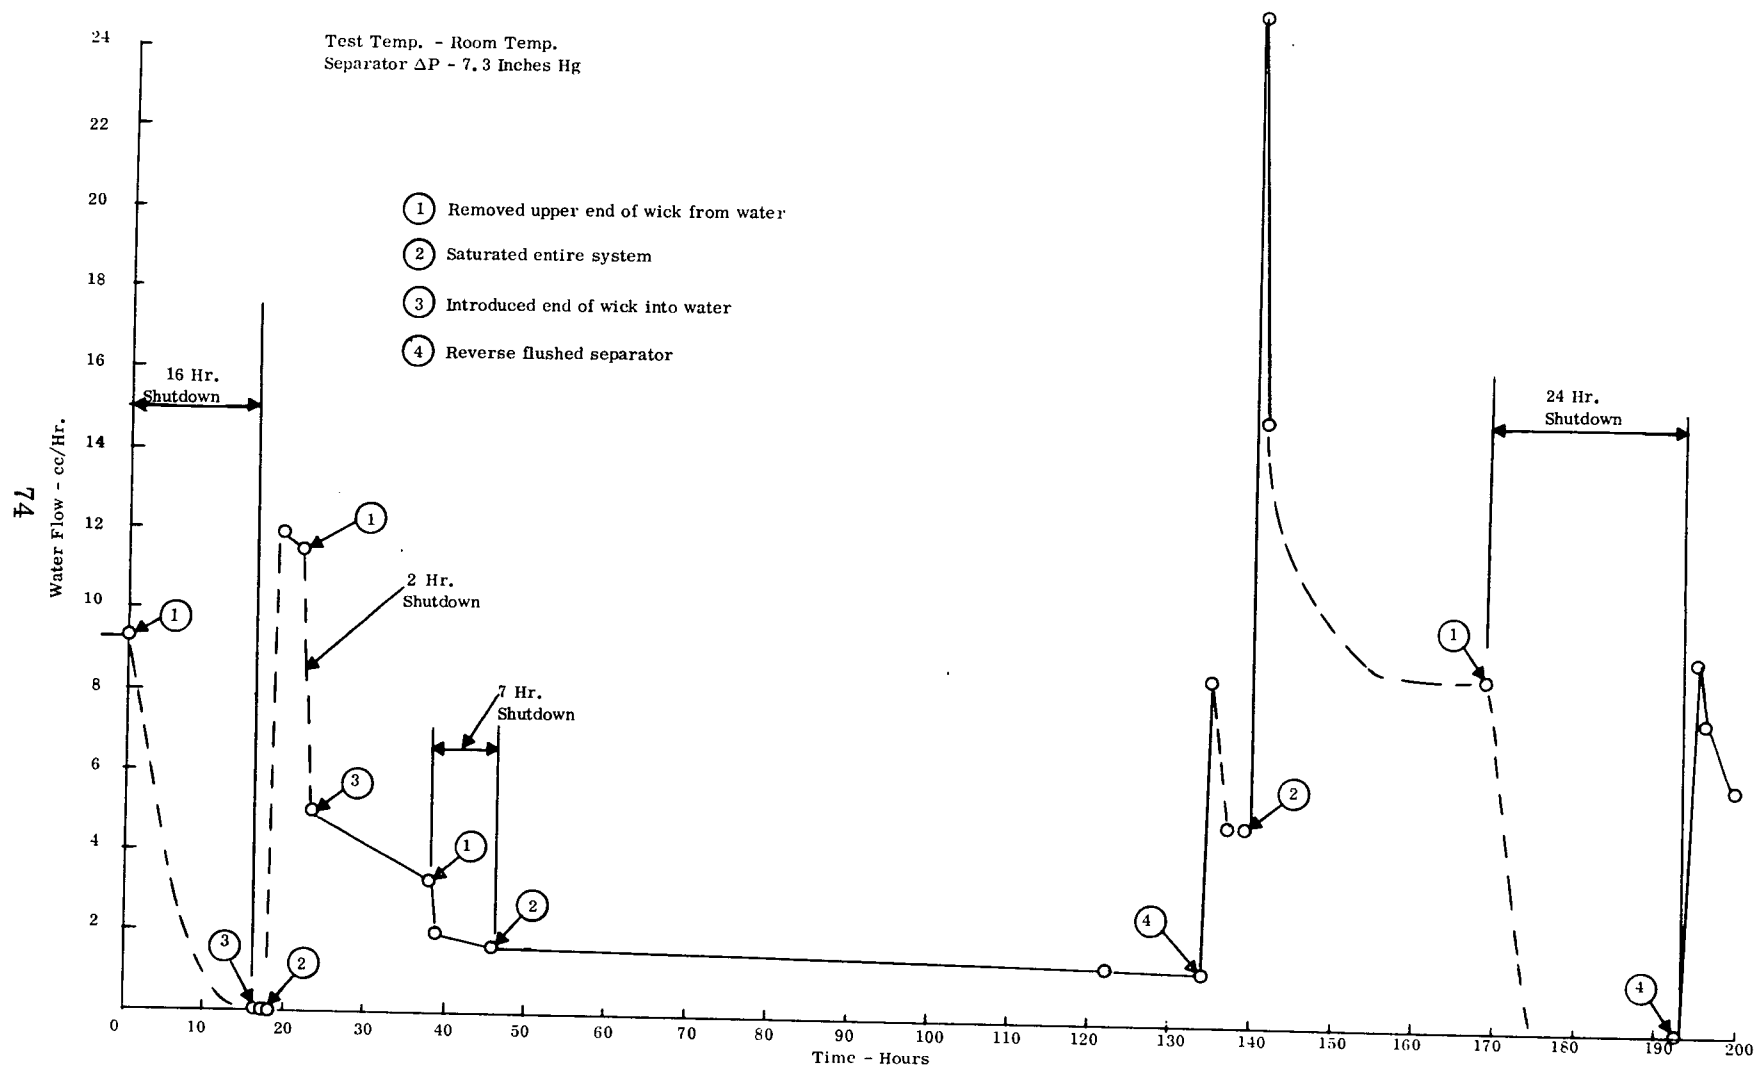
Figure 12. Test Results - Simulated Water System Space Shuttle Fuel Cell

This series of tests is summarized in the chronological plot of water flow vs. time presented in Figure 12. The results indicate the following conclusions:

- 1) Introducing water at upper end of wick will not reactivate the system after a prolonged shutdown of 16 hours.

- 2) After short shutdown of up to 7 hours, system can be reactivated by introducing water at upper end of wick.
- 3) Flow rate is reduced by a shutdown even after successful reactivation without reverse flush.
- 4) Reverse flushing improves flow rate for short term.
- 5) Reverse flushing will reactivate a system after a 24 hour shutdown.
